New Boron Longeron Makes Boeing B-1 Aircraft Flight Worthy Again

Michelle Voorheis - Materials & Process Engineer, B-1 Flight Sciences

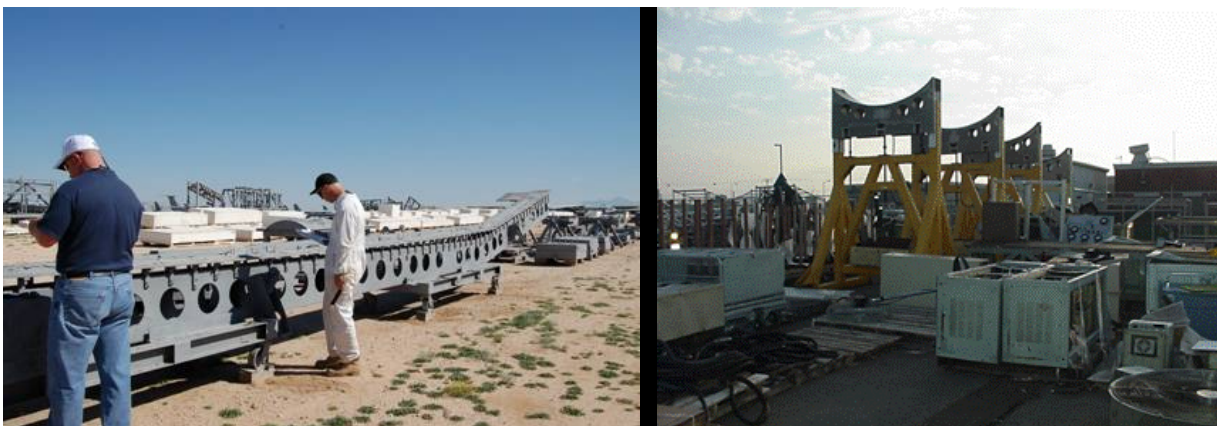
**Bond Jig Sitting in the Desert (L) and Fuselage Cradles in the Yard (R)
(Customer and AMARG Employee)**

The tools were shipped from AMARG and Tinker AFB to Boeing C-17 Tooling group (Long Beach) for refurbishment in mid-2008. Both tools required extensive restoration work to repair damage and wear from years of outdoor exposure. The bond jig, originally bare steel since it stayed in a clean room during production days, was given a custom paint scheme approved by the USG customer. The transportation dolly that was never found was fabricated new from the original vellum drawings.

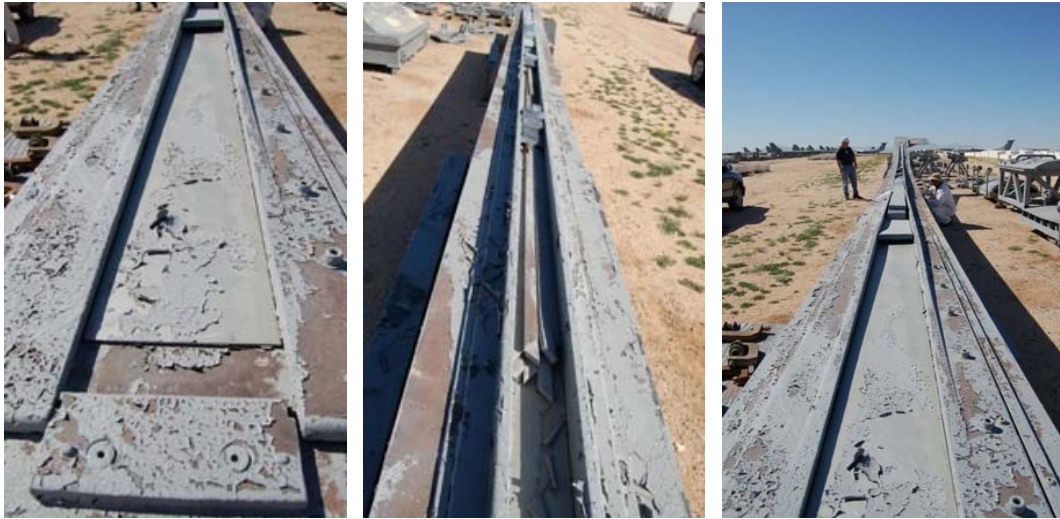
Miscellaneous Parts and Pieces of Longeron Bond Jig in Arizona Desert

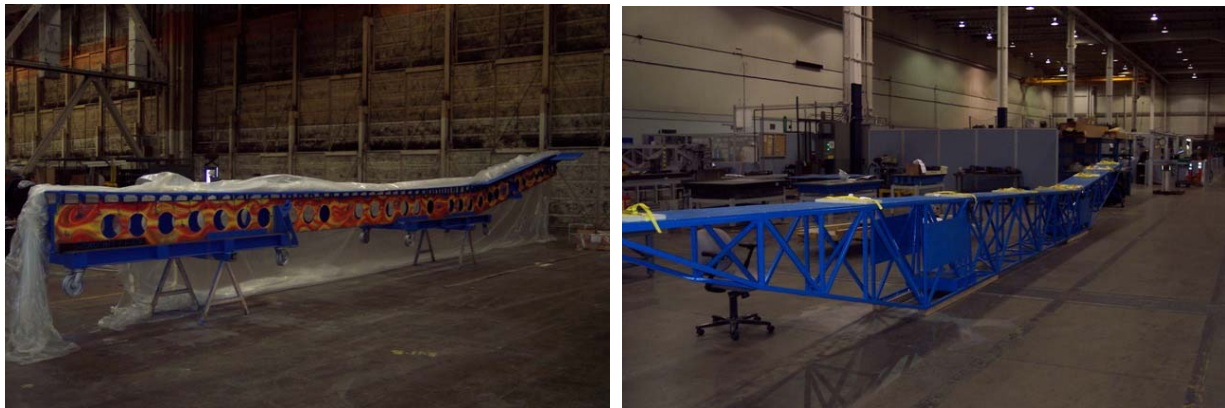
Restored Longeron Bond Jig (L) and New Transportation Dolly (R)

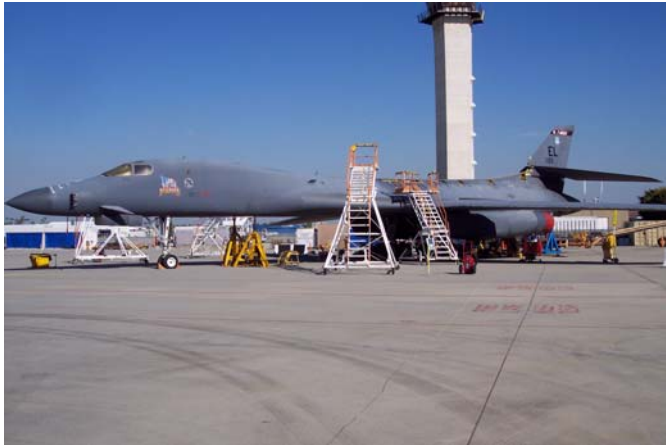
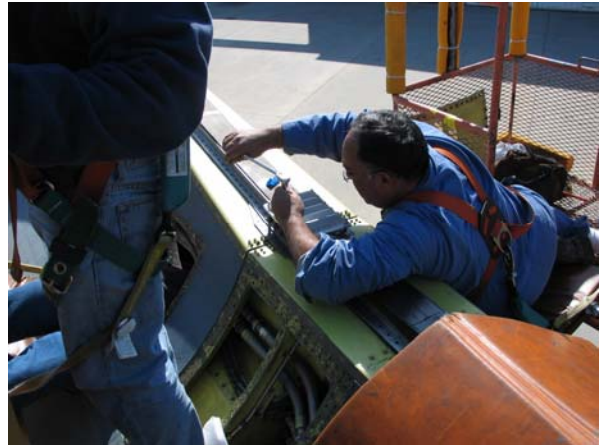
Swift Justice on Jacks (L) and Removal Operations (R)

In July 2008, the crippled B-1 was ferry-flown from Ellsworth AFB to the Boeing Recovery And Modification Services (RAMS) Center in the Long Beach for its' backbone operation. The aircraft was jig-jacked to both unload the longeron as much as possible for removal and support it while the backbone was not in the jet. Removing the longeron took about two weeks between jacking and crawling inside the narrow fuselage to reach fasteners that were never intended to be reached. Removal operations were timed with the completion of the tooling so that the longeron would be out of the aircraft for a minimal amount of time.

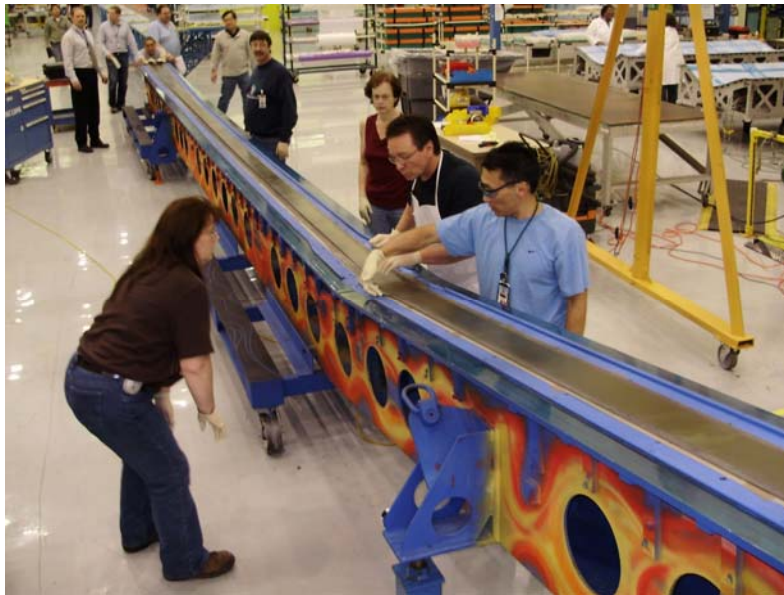
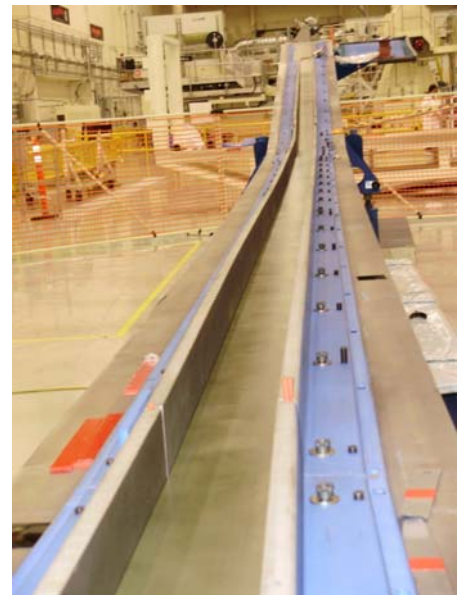
Placing the Titanium Cap on Bond Jig (L) and Building Jig Around Cap (R)

The boron/epoxy backbone of the B-1 is an extremely aggressive composite design, even by today's standards. Michael Goodrich, from the Composites and Adhesives Group (Huntington Beach) was a crucial advisor to the B-1 program regarding some of the technical items recovered from the desert, as well as assisting in the fabrication of the replacement Longeron. Due to its complexity, uniqueness and 47.5-foot length; the CFAC, with their 90-foot autoclaves and composite development shop, was selected to do the layup. Lamar Dearth, an ME at the CFAC, wrote 357 pages of planning to get the part fabricated! The actual fabrication work of the longeron began after significant activity regarding reassembly of the bond jig by the CFAC Tooling group. The bond jig is assembled AROUND the titanium base plate in order to make a net part.

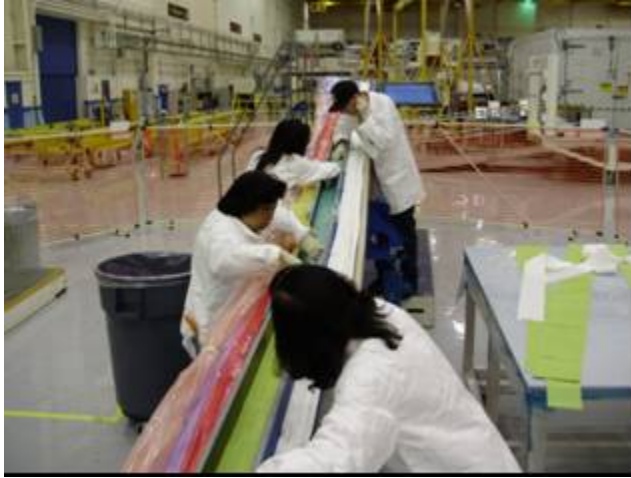
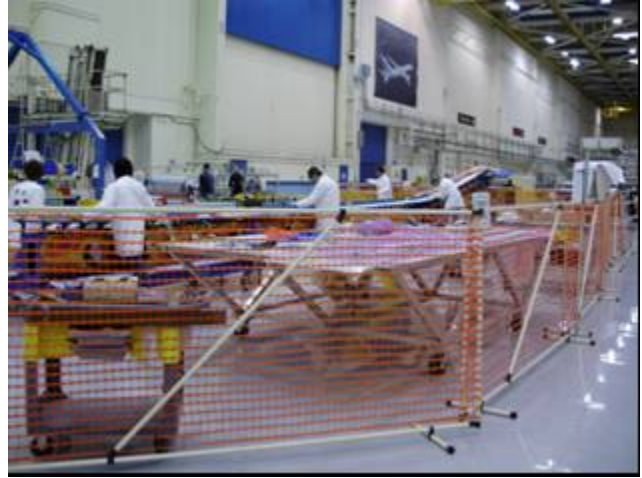
24/7 Layup Operations for Boron/Epoxy Longeron

Contours of the tool/part make it extremely difficult to use current practice layup and inspection verification techniques; consequently, it was necessary to go back to the "old ways" in terms of accepting the tool and inspecting the layup (think mylars and rulers).

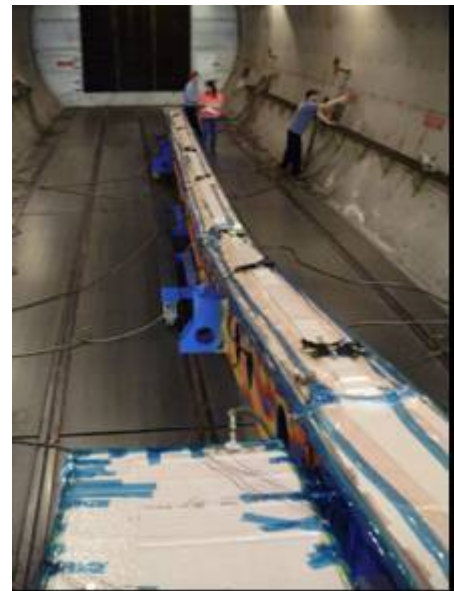
Final Bag (L) and Setting Up in 90-ft Autoclave (R)

The original boron/epoxy material supplier (Specialty Materials, Inc.) supplied the 14,000 feet of 4-in wide unidirectional tape that was necessary to fabricate the longeron. The amount of 5.6-mil diameter boron filament used to make this part can encircle the earth over 1.5 times!!! The material out-time required that the 330-ply longeron, built to NET dimensions of 4.00-in (+0.005/-0.000), be completed in no more than 360 hours (15 days). The CFAC layup crews worked continuously 24/7 for eleven (11) days to meet that deadline and 330 plies later; the new Longeron was ready for the 90-foot autoclave!

The 22-hour cure cycle did help create a perfect part but not without at least one notable harrowing event ... During a hold right after a resin exotherm spike, all vacuum was lost (blown bag) and it was too far into the cure cycle to stop the autoclave and assess potential damage to the half-million dollar material. The final twelve hours were pins and needles. When all was done, an ultrasonic inspection showed a flawless Longeron for delivery to the RAMS Center, where 86-0125 was waiting.

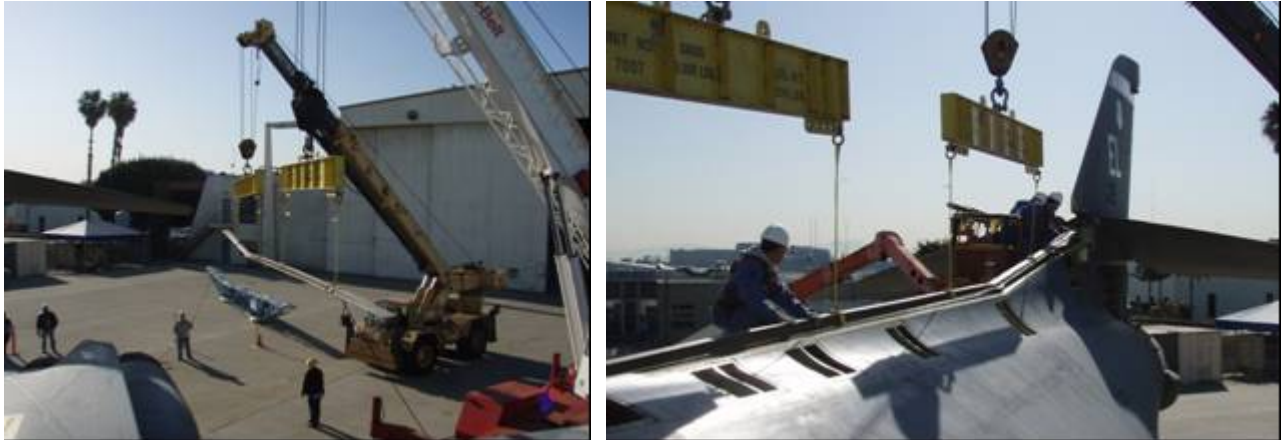
Reinstalling New Longeron (R) at RAMS Center
