Compression After Impact (CAI) Response of Quasi-Isotropic Laminates with and without Hy-Bor[®] for the Zero-Degree Plies

Alan T. Nettles PhD

ABSTRACT

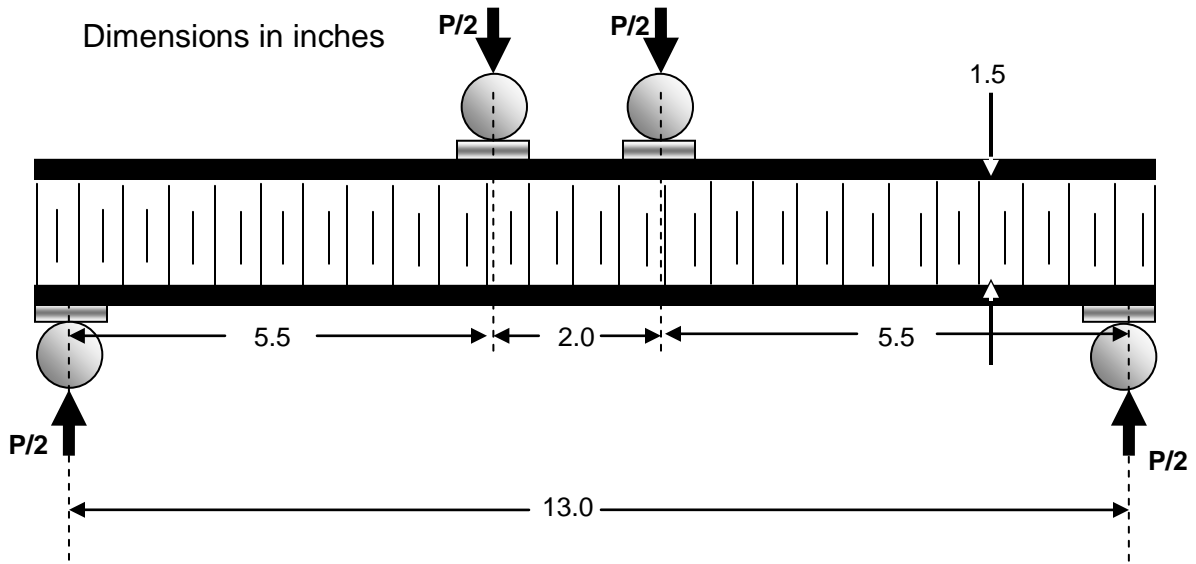
Figure 1. Schematic of compression specimen used in this study.

In order to manufacture the compression specimens needed for the four point bend method, honeycomb core and a suitable "tension" face sheet material needed to be chosen. High density aluminum core 1.5 inches thick with a density of 12 lb/ft³ was chosen due to the high strength of the material being tested. The "tension" face sheet chosen was a bi-directional laminate of IM7/MTM-45 since the modulus of this laminate had already been characterized (13.0 Msi). This modulus would be needed when calculating the compressive stresses in the "top" or "compression" face sheet. Both face sheets were prepared for bonding to the aluminum core by mechanical abrading until water no longer "beaded" on the surface. An epoxy film adhesive was used to bond the laminates that made up the face sheets to the high density aluminum honeycomb core. This process took place at 250 °F and 80 psi to ensure good filleting of the adhesive between the core and face sheets. Once the face sheets had bonded to the core, beam sections 2.0 inches wide were cut from the sandwich panel to form the compression test specimens. A schematic of the compression test specimen used in this study is shown in Figure 1.

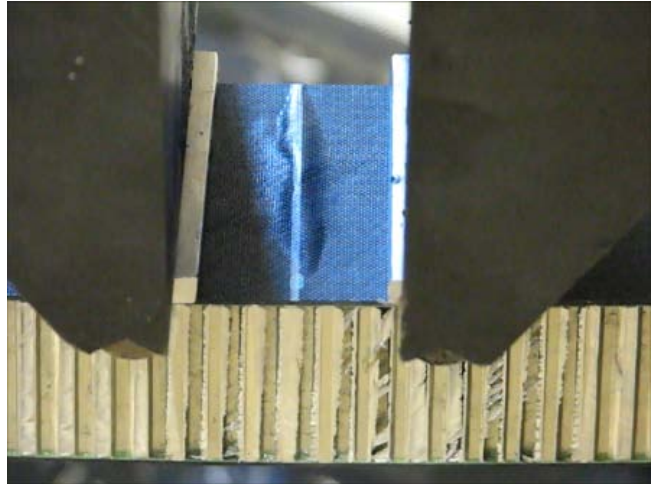
2. Blister has undergone very little growth right before ultimate failure

Figure 4. Failure phases of impacted Hy-Bor[®] 208 specimens.

One unique aspect of the impacted Hy-Bor[®] samples was that the failure occurred in two distinct phases. In the first phase of failure some of the plies “pop up” in what is thought to be sublaminar buckling from a large delamination above or below the 0°-plies. Instead of failing catastrophically the boron fibers apparently have enough strength to still carry the applied load. As the load is increased further, catastrophic failure occurs as the second and final phase of failure. This behavior highlights the structural aspects of the added boron and results in a type of “fail-safe” material akin to skin/stringer structure. Figure 4 shows photographs of the phases of compressive behavior for the Hy-Bor[®] 208 laminates. These photographs were taken from a digital video of a CAI test.

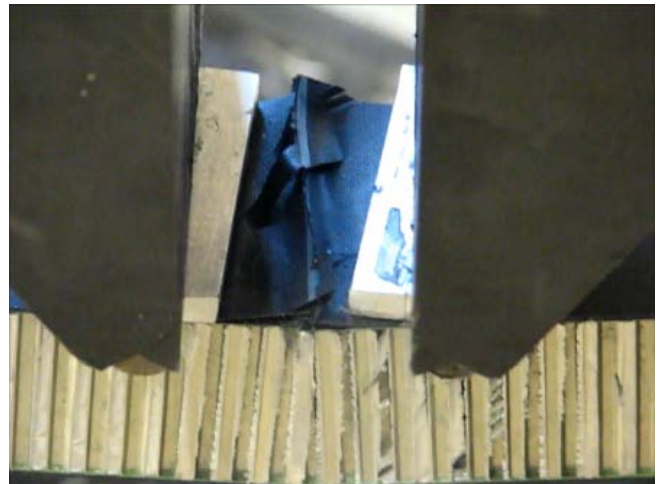
3. 0°-plies fail resulting in ultimate failure

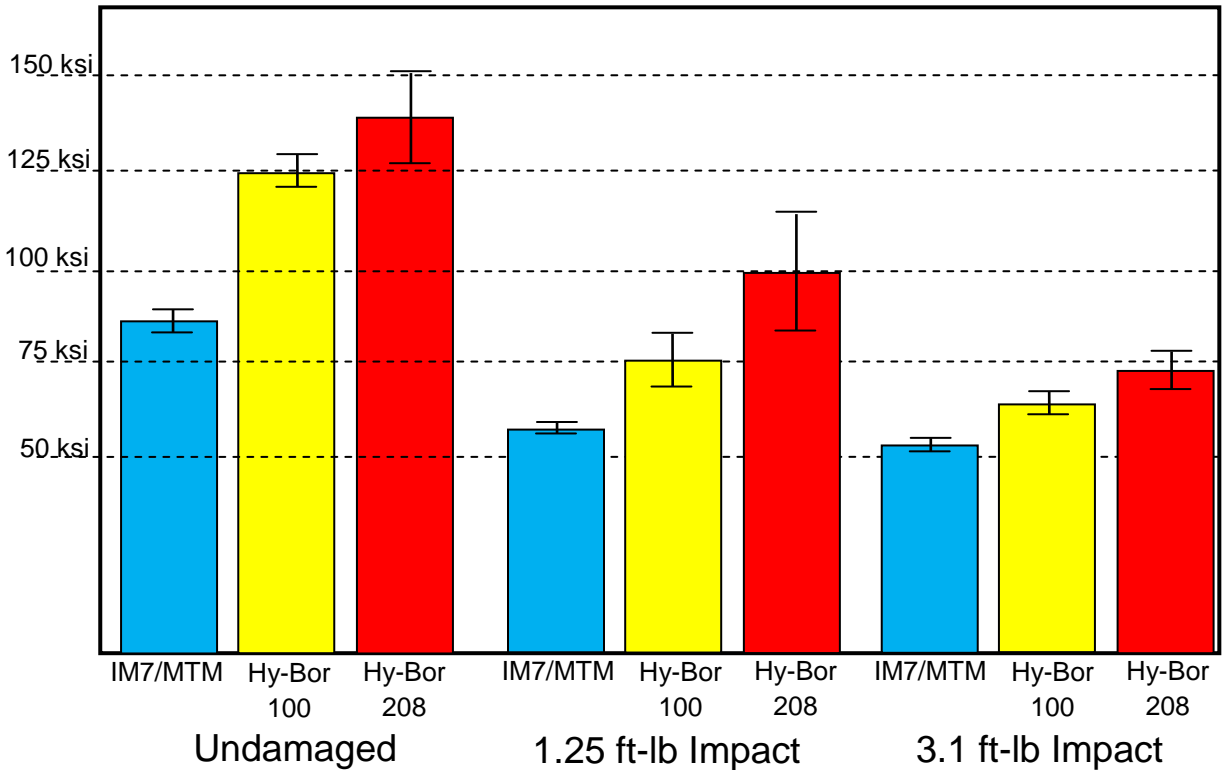
Figure 5. Graphical summary of compression strength values

A graphic summary of the results in Table 1 are shown in Figure 5.
