Compression After Impact (CAI) Response of Quasi-Isotropic Laminates with and without Hy-Bor® for the Zero-Degree Plies

Alan T. Nettles PhD Visiting Scholar, Stanford University Department of Aeronautics and Astronautics

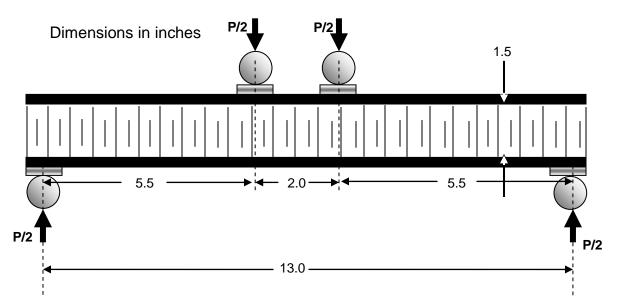
Figure 1. Schematic of compression specimen used in this study.

In order to manufacture the compression specimens needed for the four point bend method, honeycomb core and a suitable "tension" face sheet material needed to be chosen. High density aluminum core 1.5 inches thick with a density of 12 lb/ft³ was chosen due to the high strength of the material being tested. The "tension" face sheet chosen was a bi-directional laminate of IM7/MTM-45 since the modulus of this laminate had already been characterized (13.0 Msi). This modulus would be needed when calculating the compressive stresses in the "top" or "compression" face sheet. Both face sheets were prepared for bonding to the aluminum core by mechanical abrading until water no longer "beaded" on the surface. An epoxy film adhesive was used to bond the laminates that made up the face sheets to the high density aluminum honeycomb core. This process took place at 250 °F and 80 psi to ensure good filleting of the adhesive between the core and face sheets. Once the face sheets had bonded to the core, beam sections 2.0 inches wide were cut from the sandwich panel to form the compression test specimens. A schematic of the compression test specimen used in this study is shown in Figure 1.

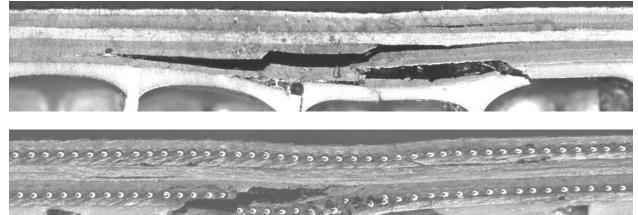
Figure 2. Low impact level damage to specimens used in this study.

Some of the beam specimens of both IM7/MTM-45 and Hy-Bor[®] 208 and Hy-Bor[®] 100 were impacted utilizing an instrumented drop weight tower. The impact diameter used was 0.25 inches in order not to cause a large damage zone that would interact with the specimen edges. The two impact energies utilized were 1.25 and 3.1 ft-lbs. The aim of these impacts was not so much to create a realistic situation as it was to simply cause levels of damage in the specimen that would lower its compression strength. A visual indication of these levels of damage severity on the baseline and both type of Hy-Bor[®] specimens are shown in Figure 2 for the low-energy impacts and in Figure 3 for the high-energy impacts.

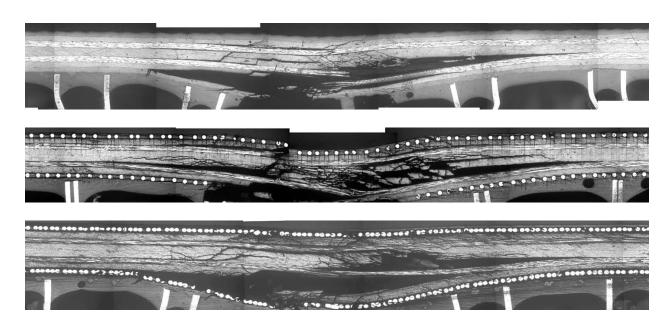
Figure 3. High impact level damage to specimens used in this study.

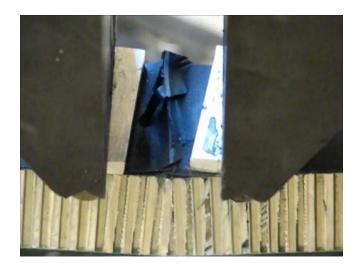
1. Blister pops up above impact site upon sublaminate buckling between 80-90% of ultimate failure load

2. Blister has undergone very little growth right before ultimate failure

3. 0°-plies fail resulting in ultimate failure

Figure 4. Failure phases of impacted Hy-Bor® 208 specimens.

One unique aspect of the impacted Hy-Bor® samples was that the failure occurred in two distinct phases. In the first phase of failure some of the plies "pop up" in what is thought to be sublaminate buckling from a large delamination above or below the 0°-plies. Instead of failing catastrophically the boron fibers apparently have enough strength to still carry the applied load. As the load is increased further, catastrophic failure occurs as the second and final phase of failure. This behavior highlights the structural aspects of the added boron and results in a type of "fail-safe" material akin to skin/stringer structure. Figure 4 shows photographs of the phases of compressive behavior for the Hy-Bor® 208 laminates. These photographs were taken from a digital video of a CAI test.

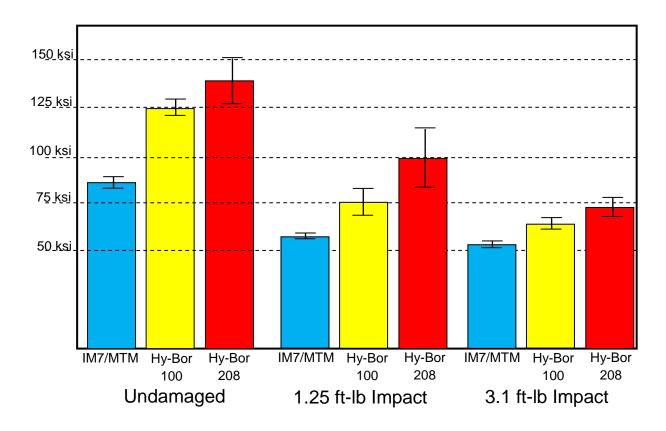
Figure 5. Graphical summary of compression strength values

Specimen	Impact Energy (ft-lbs)	Ultimate Compressive Stress
		(ksi)
IM7/MTM-45	0	86.6 ± 3.1
Hy-Bor® 100	0	124.9 ± 4.3
Hy-Bor® 208	0	139.7 ± 12.1
IM7/MTM-45	1.25	58.1 ± 1.6
Hy-Bor® 100	1.25	75.8 ± 7.0
Hy-Bor® 208	1.25	98.8 ± 15.6
IM7/MTM-45	3.1	53.8 ± 1.7
Hy-Bor® 100	3.1	64.6 ± 3.1
Hy-Bor® 208	3.1	73.5 ± 5.1

A graphic summary of the results in Table 1 are shown in Figure 5.
